Collection: Deaver, Michael Folder Title: Report on the Commission on the Renovation of the Executive Mansion Box: 39

OF THE EXECUTIVE MANSION SION ON THE PENOVATION DE THE COMMIS-PEDOR OF THE COMMIS-

In accordance with the provisions of Public Law No. 40, 81st Congress, 1st Session, we have the honor to submit this final report of the Commission on Renovation of the Executive Mansion.

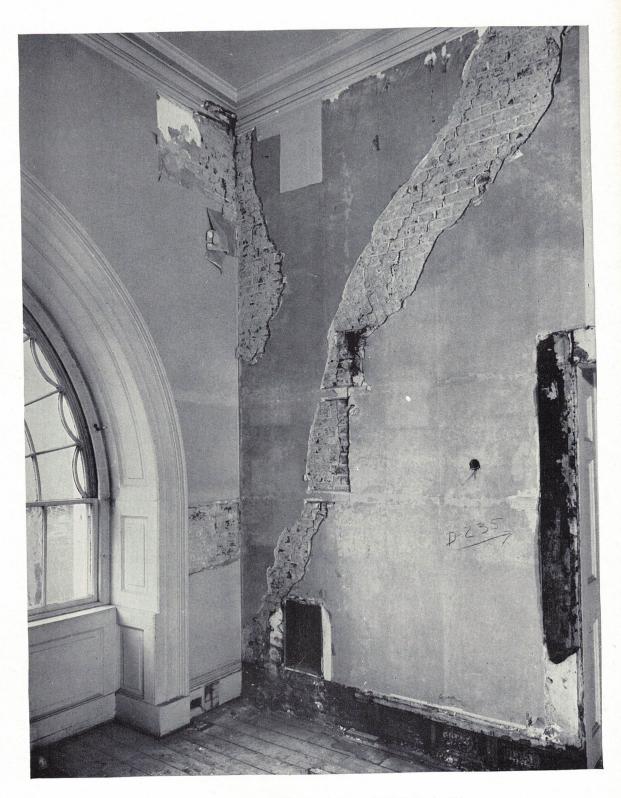
Cracks in the Northwest Corner and in the North Brick Wall in the West Sitting Room, on the Second Floor, as revealed in investigation prior to the Renovation

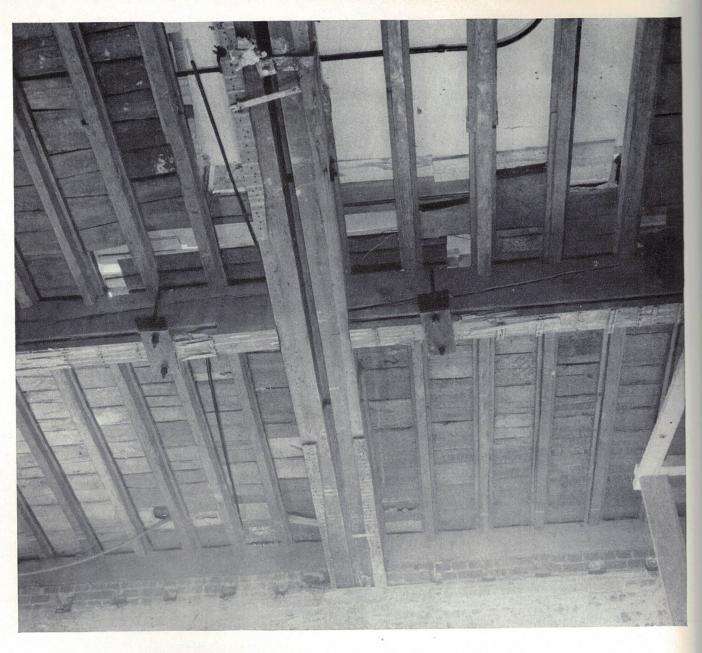
Split in Beam under Room Miss Margaret Truman Occupied as Sitting Room. Break was the Result of Cutting away Beam at Bearing

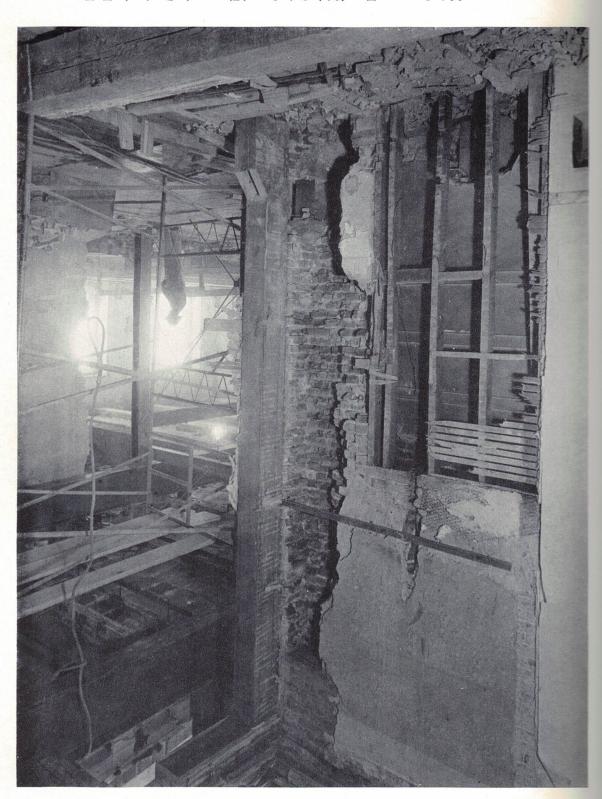
Main Support at Top of Main Stair, Second Floor, under Bearing for T4 Truss

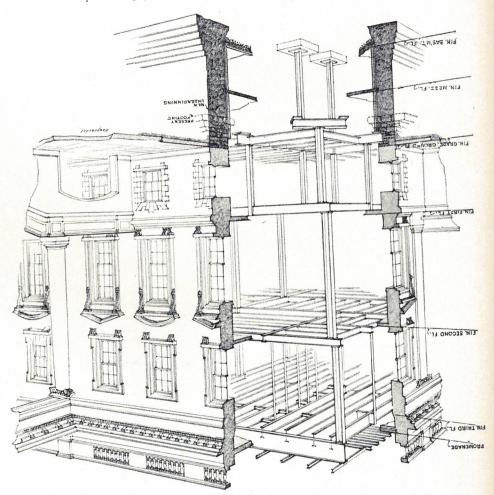
Diagram Showing Wall Underpinning and New Steel Construction

It was necessary, in conformity with the decision to preserve the existing exterior walls, to underpin these walls with concrete piers having footings at varying depths of 24 to 27 feet below the ground level

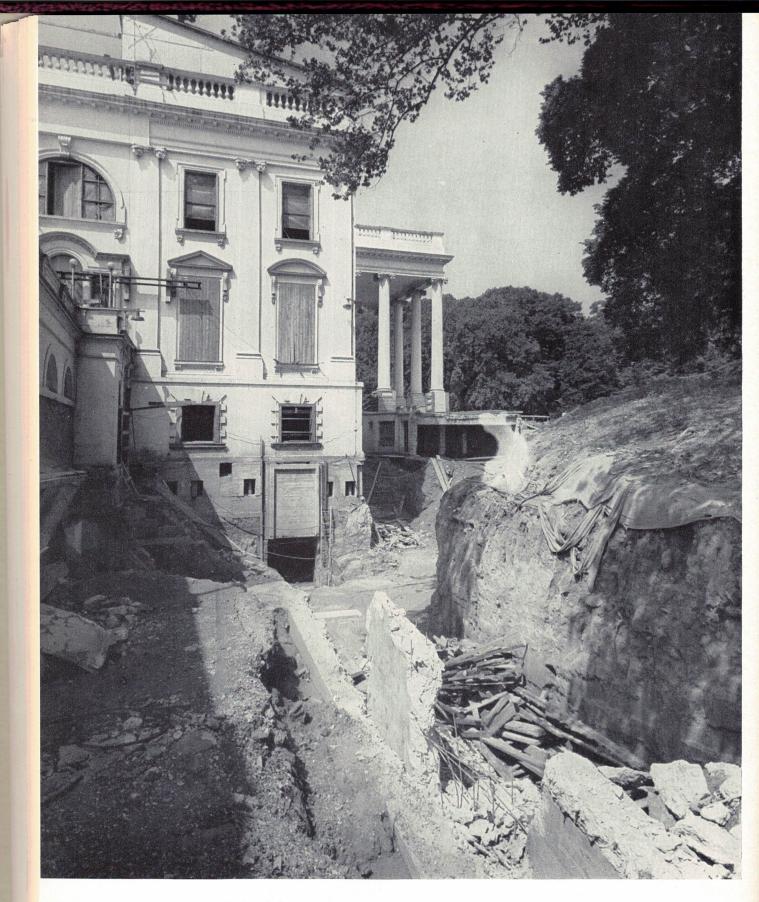
Construction and Excavation at Northeast Corner

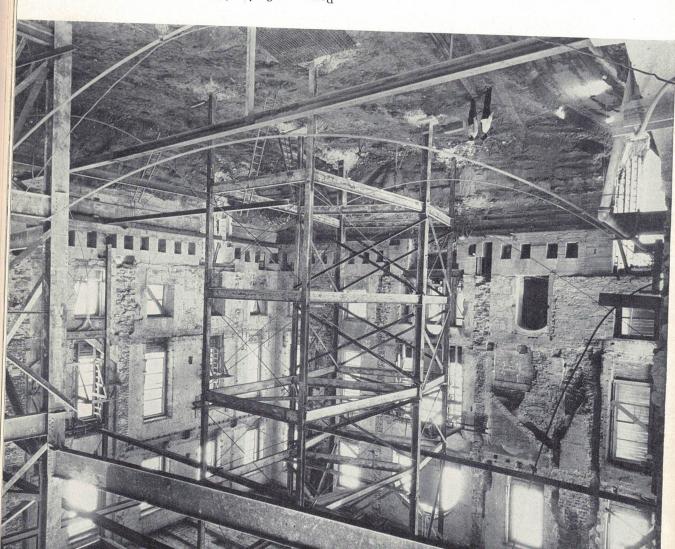
Permanent Steel and Temporary Bracing in Interior of White House

a new supporting structural steel frame was erected on these footings within the existing masonry walls of the building, thus changing it from a wall bearing construction to a modern steel frame. For the most part the columns at the walls were to run within or close to the walls, but in a few cases the walls were cut back to receive the columns.
