The Commission found that the cause of the
accident resulted from the failure of the
pressure seal in the aft field joint of the
right solid rocket booster.

The Cause of the Accident

The consensus of the Commission and participating investigative agencies is that the loss of the Space Shuttle Challenger was caused by a failure in the joint between the two lower segments of the right Solid Rocket Motor. The specific failure was the destruction of the seals that are intended to prevent hot gases from leaking through the joint during the propellant burn of the rocket motor. The evidence assembled by the Commission indicates that no other element of the Space Shuttle system contributed to this failure.

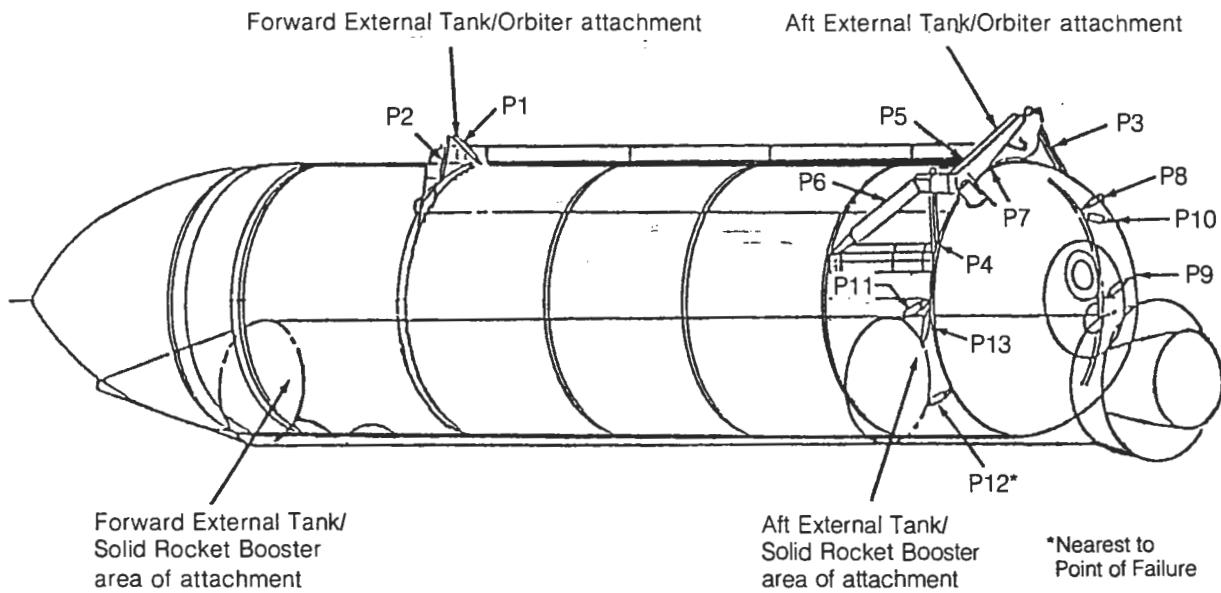
Figure 10
 Drawing of transparent External Tank, with right Solid Rocket Booster on far side, shows location of struts measured in table of strut loads. (Figure 9)

Engine thrust buildup, the resulting forces and moments, vehicle and pad stiffness, and clearances were as expected. The resultant total bending moment experienced by STS 51-L was 291×10^6 inch-pounds, which is within the design allowable limit of 347×10^6 inch-pounds.

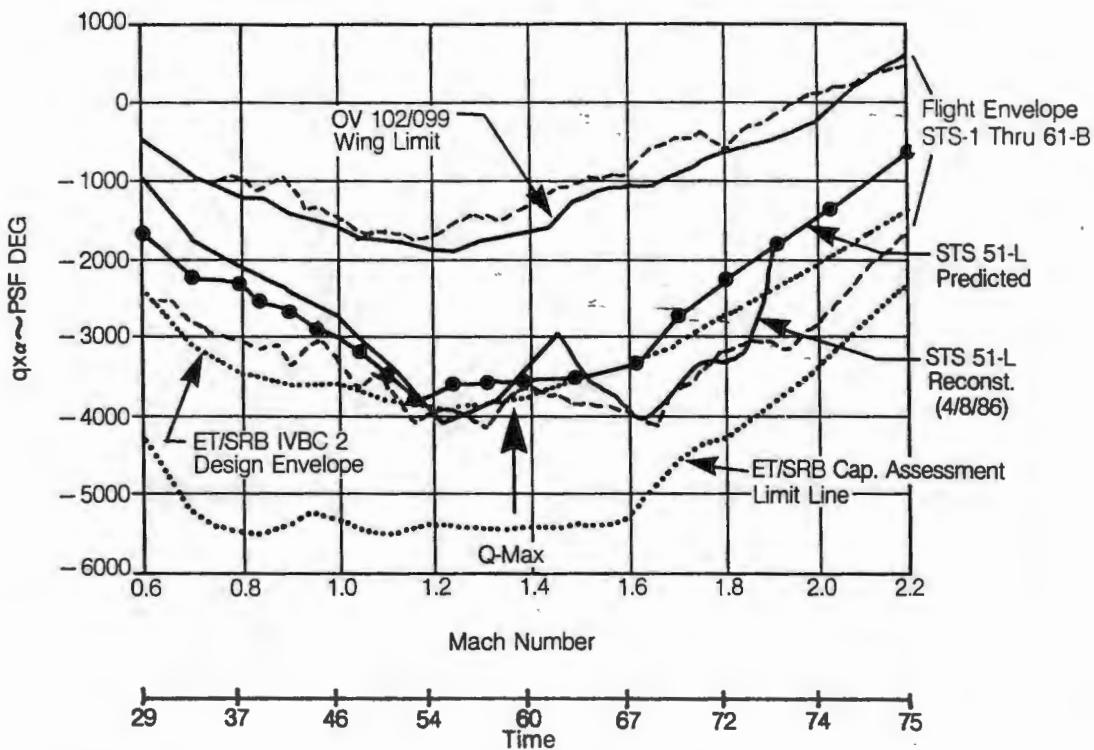
Figure 11

The Solid Rocket Motor field joint axial tension loads were substantially lower at maximum dynamic pressure than at lift off: 11.6×10^6 pounds for the forward field joint and 10.6×10^6 pounds for the aft field joint. Compared to the internal pressure loads, the dynamic variations due to wind shear were small—about $\frac{1}{15}$ those of the pressure loads. *These loads were well below the design limit loads and were not considered the cause of the accident.*

The loads in the pitch plane are shown by the solid line marked "STS 51-L RECONST." The curve "STS 51-L PREDICTED" give the loads expected before the flight. The dashed lines show the limit of experience from STS-1 through 61-B. The present design limits are the two lines marked "OV

102/099 WING LIMIT" above, and "ET/SRB CAP. ASSESSMENT LIMIT LINE" below. (After STS-6, the wing was strengthened. The previous design limits were "ET/SRB IVBC 2 DESIGN ENVELOPE" below, and a curve in the positive region of $q \times \alpha$ above)

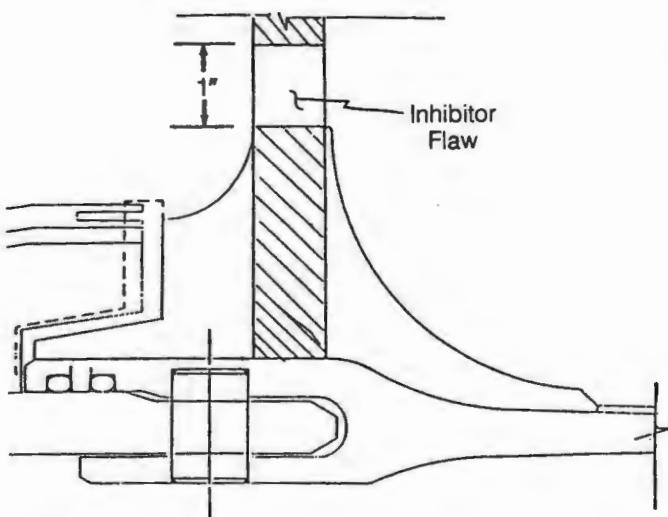
Figure 12
Sketch shows location of assumed inhibitor flaw used in eliminating such a problem as a possible cause.

Evaluation of potential insulation or inhibitor (see Figure 12) flaws against the three criteria above resulted in elimination of all candidates except a defect in the forward-facing inhibitor. This potential failure mode was evaluated by assuming a 1-inch-diameter hole in the inhibitor. Analysis indicated that the change in motor internal pressure resulting from this failure would probably not be detected. However, an erosion rate substantially higher than the observed values would be required to burn through the membrane by 58 seconds. In addition, the assumed flaw is unlikely since the inhibitor is constructed by vulcanizing eight individual plies of the material. Subsequent damage of the magnitude required is improbable and would be easily detected.

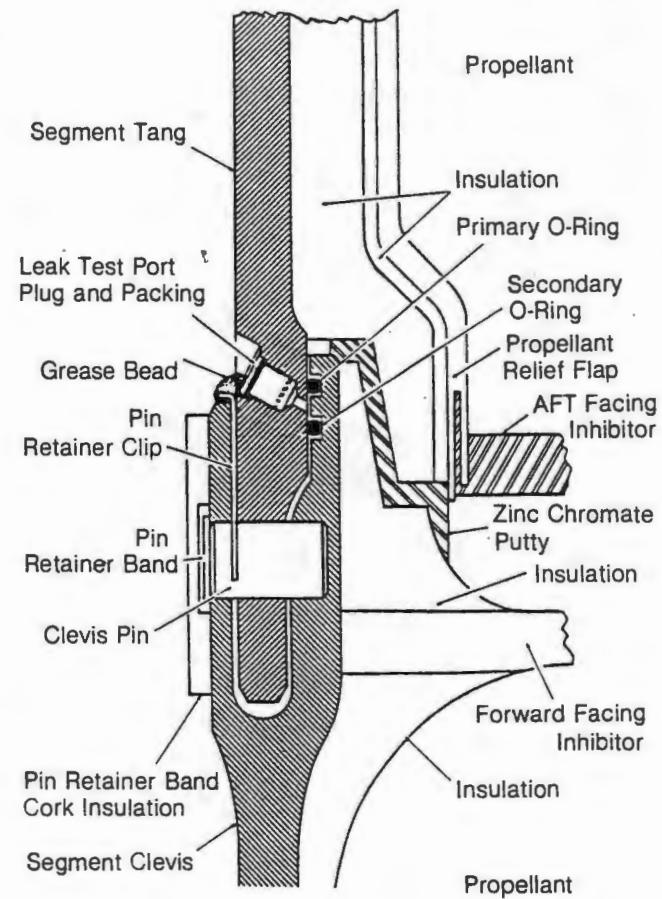
Figure 14
Solid Rocket Motor cross section shows positions of tang, clevis and O-rings. Putty lines the joint on the side toward the propellant.

pressure loads are applied to the joint during ignition. Should pressure actuation be delayed to the extent that the gap has opened considerably, the possibility exists that the rocket's combustion gases will blow by the O-ring and damage or destroy the seals. The principal factor influencing the size of the gap opening is motor pressure; but, gap opening is also influenced by external loads and other joint dynamics. The investigation has shown that the joint sealing performance is sensitive to the following factors, either independently or in combination:

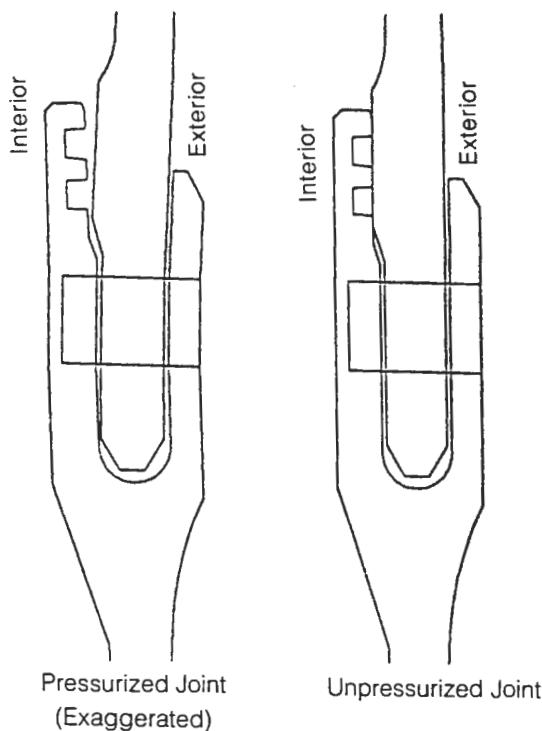
Figure 16

The joint deflection analysis established time histories for gap openings for primary and secondary O-rings for all field joints. For the aft field joints these data indicate gap opening increases of approximately 0.029 inches and 0.017 inches for the primary and secondary O-rings respectively. These values were used for sub-scale dynamic tests. Due to differences in motor pressure and loads, the gap opening increases for forward field joints are approximately 0.008 inches greater than for the aft field joints. Gap opening changes (called delta gap openings) versus time are shown in Figure 17 for the aft field joints. The total gap at any time also depends on the initial static gap, on rounding effects during segment pressurization, and on loadings due to struts and airloads. Sub-scale tests were run containing combinations of the above variables, but did not include the effects of the struts and airloads.

Drawings show how tang/clevis joint deflects during pressurization to open gap at location of O-ring slots. Inside of motor case and propellant are to left in sketches.

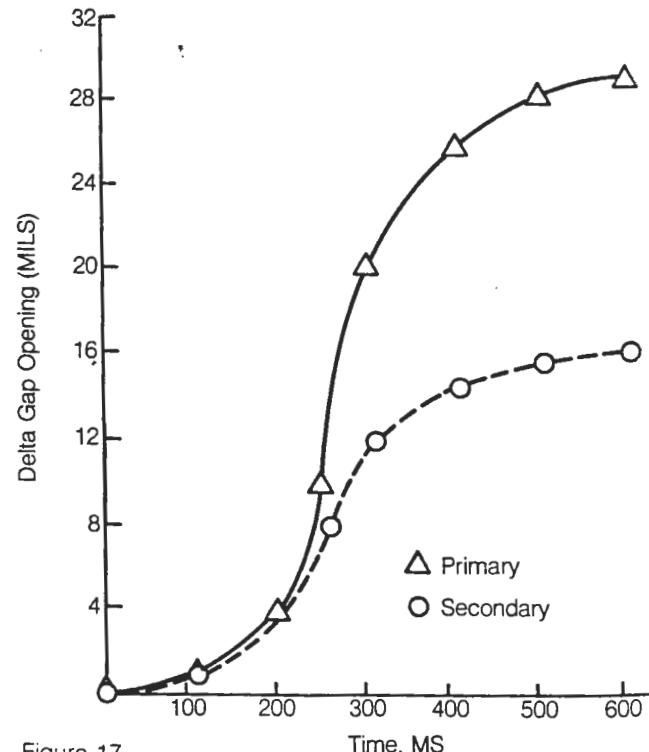
Figure 17

Graph plots changes in right booster's aft field joint primary and secondary gap openings. Horizontal scale is time in milliseconds from ignition.

Consistent results from numerous O-ring tests have shown a resiliency degradation with reduced temperatures. Figure 23 provides O-ring recovery from 0.040 inches of initial compression versus time. This shows how quickly an O-ring will move back towards its uncompressed shape at temperatures ranging from 10 to 75 degrees Fahrenheit. When these data are compared with the gap openings versus time from Figure 17, it can be seen that the O-rings will not track or

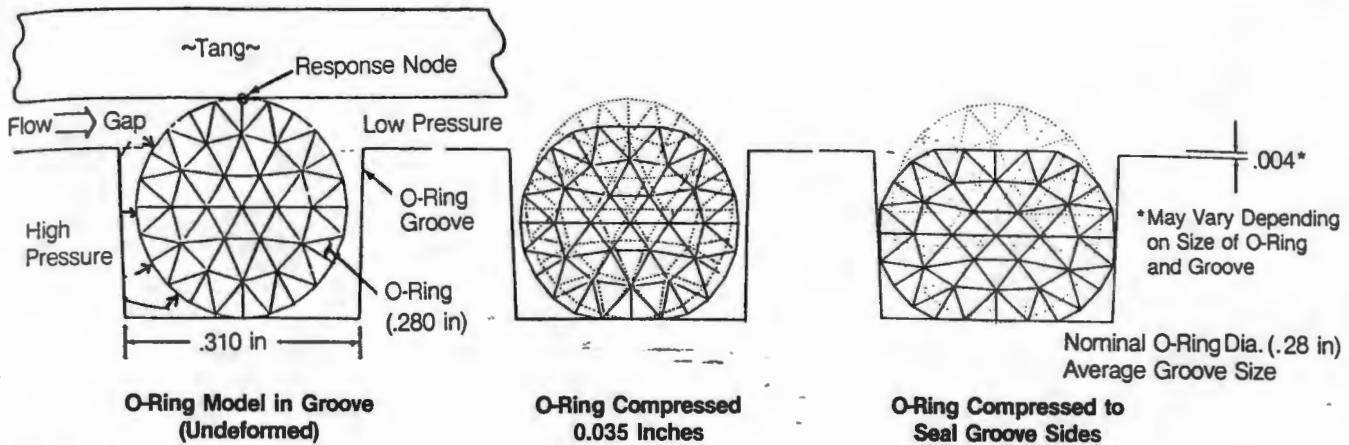
Figure 18

Drawings show how progressive reduction of gap between tang and clevis can inhibit and eventually block motor cavity's high-pressure flow from getting behind O-ring.

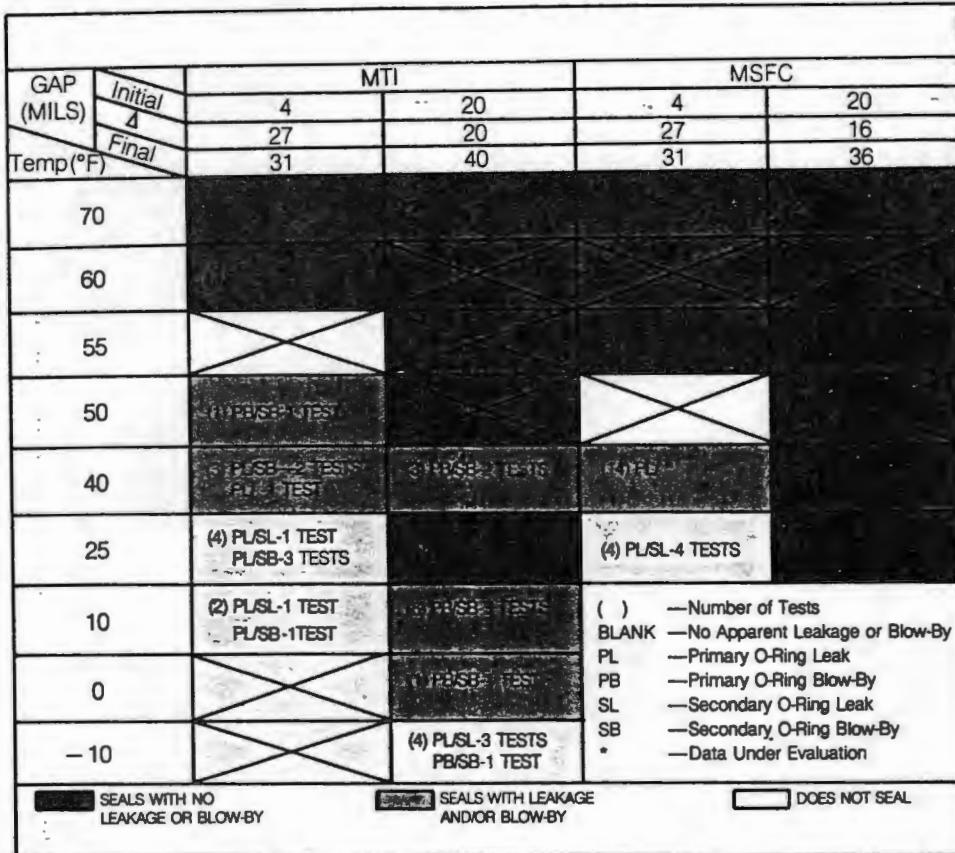
Summary of Dynamic Test Results

Figure 19
Table plots results of tests of .004 and .020 inch initial gap openings over the range of temperatures in left hand vertical column.

the O-rings at a specific initial gap and squeeze condition uniformly around the circumference. It is not certain what the effect of differences in circumferential gaps might be in full size joints. Such effects could not be simulated in the sub-scale test results reported above.

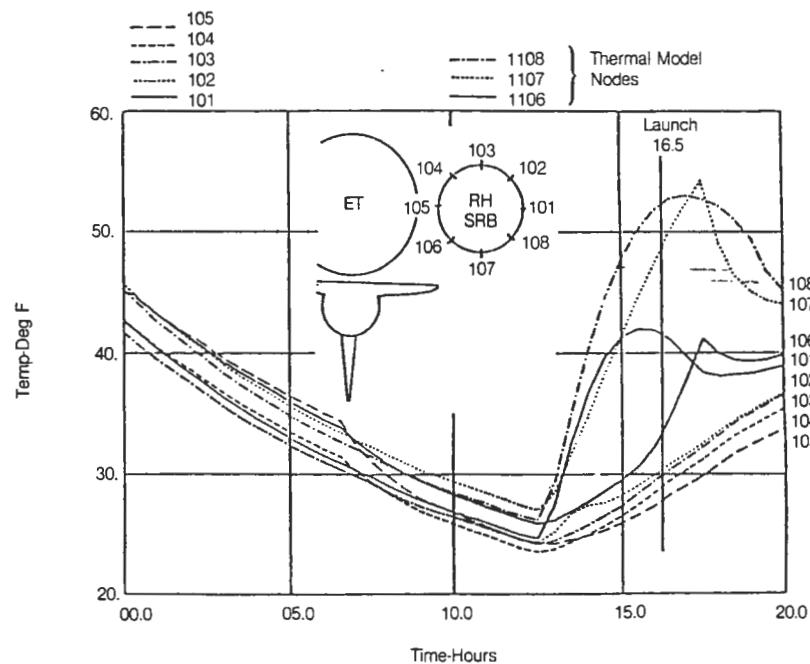
Figure 20

Temperature model for 51-L right solid booster aft segment circumferential positions from 16.5 hours prior to launch to 3.5 hours after launch.

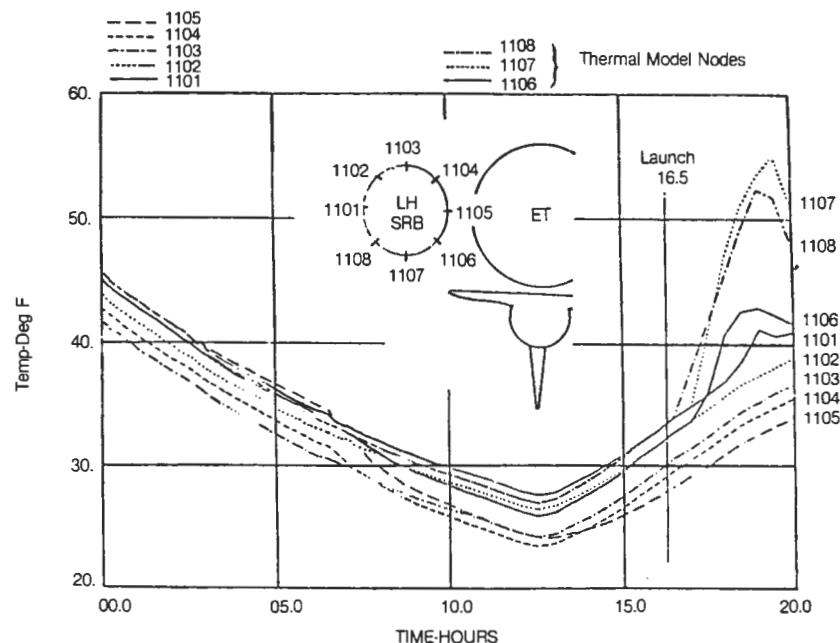
Figure 21

Temperature model for 51-L left solid booster aft segment circumferential positions from 16.5 hours prior to launch until 3.5 hours after launch.

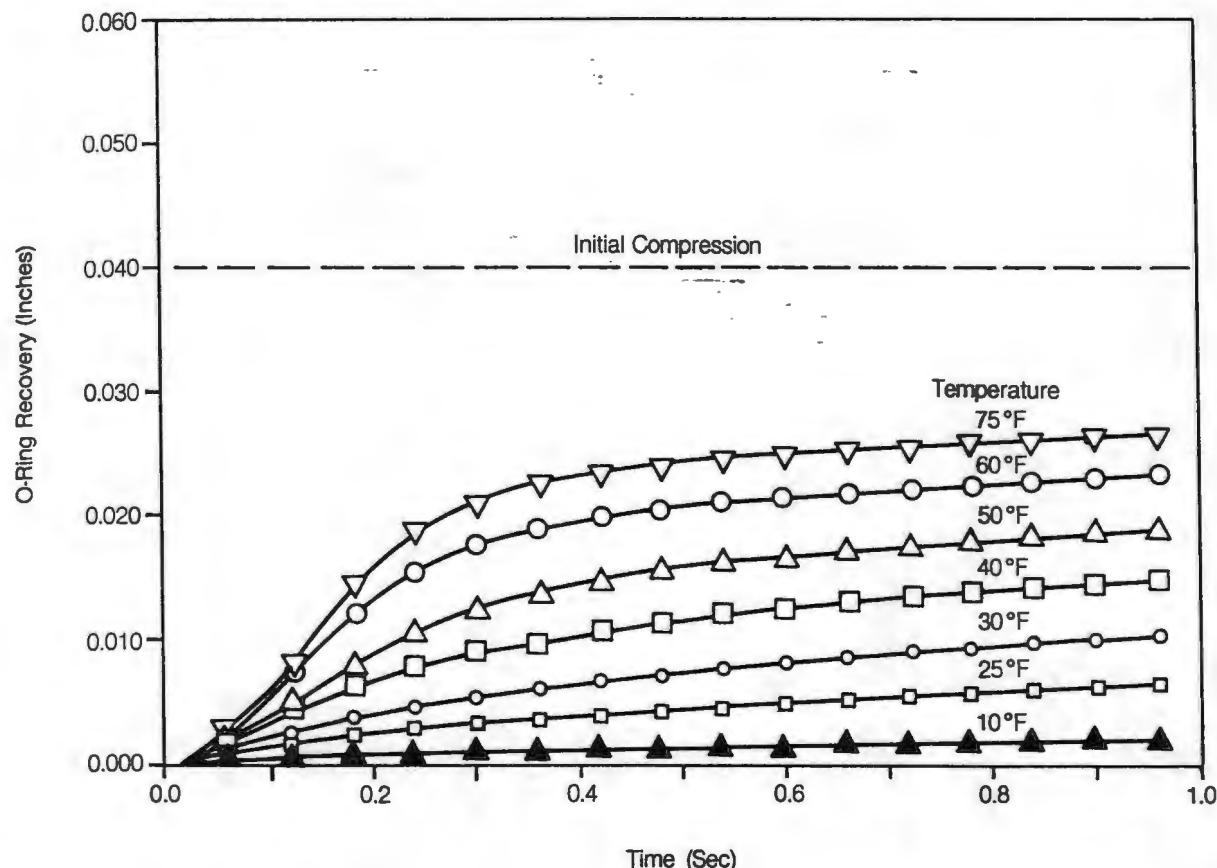
Figure 23
Graph plots O-ring shape recovery in inches against time in seconds for a variety of temperatures.

Note: Average O-Ring Recovery at Various Test Temperatures During First Second After Load Release. Initial Compression of 40 Mils Was Maintained for 2 Hours.

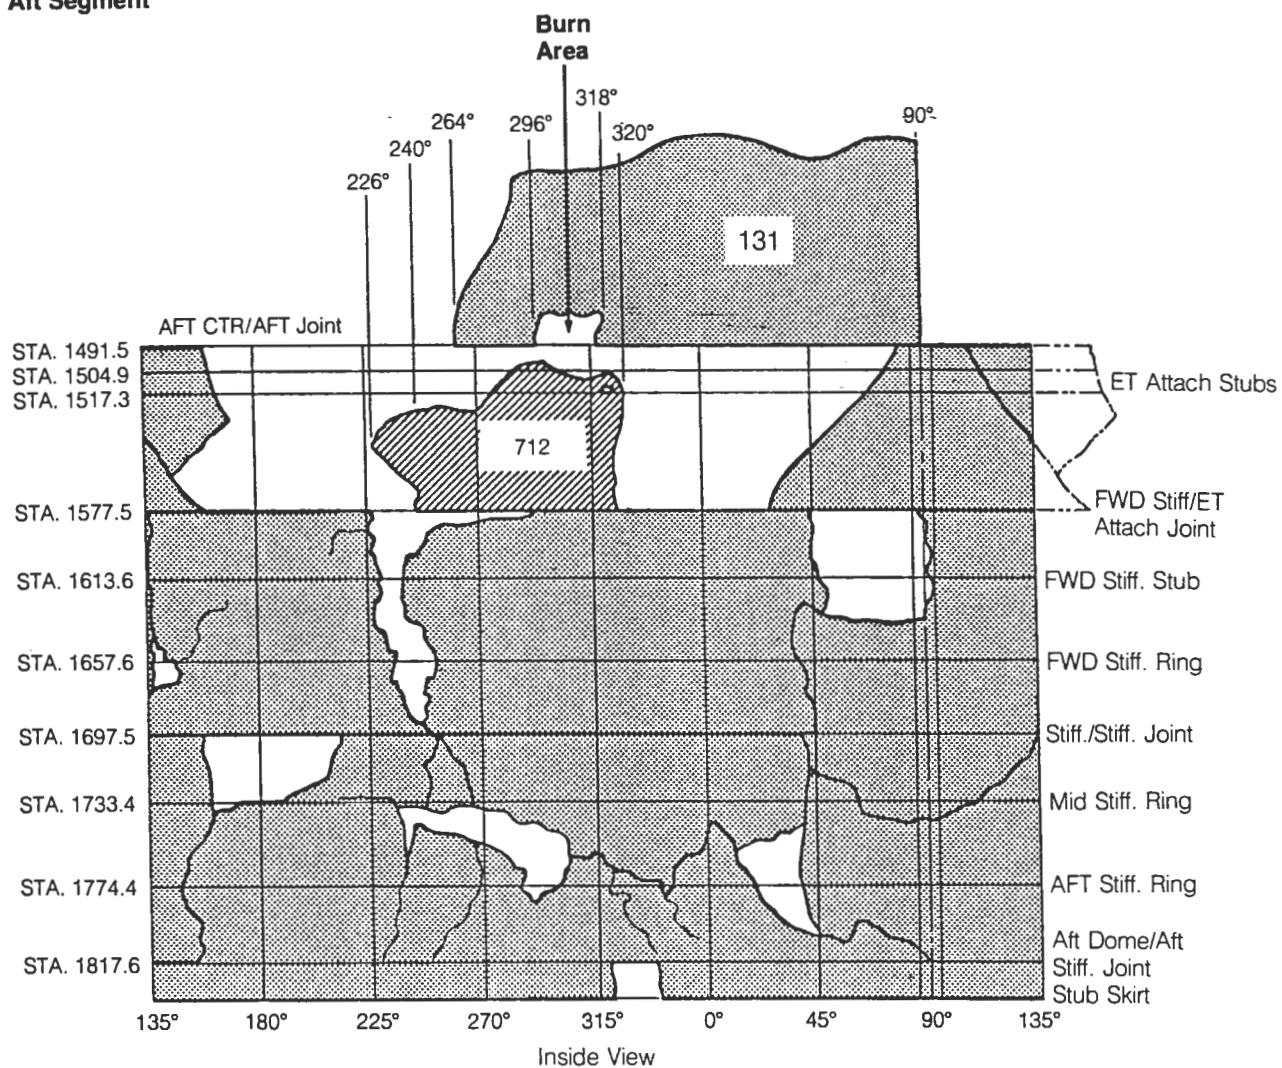
RH SRB Recovered Debris
Aft Segment

Figure 25
Drawing depicts pieces of right Solid Rocket Booster aft segment recovered. At top is piece of aft center segment.

strut. This location was within the center of the burned out zone on the right Solid Rocket Booster (photo G). As a matter of interest, the P12 strut is located close to the point on the circumference where the booster case experiences maximum radial deflection due to flight loads. It seems likely that the plume from the hole in the booster would impact near the location of the P12 strut connection and the External Tank. Using geometric considerations alone suggests this strut separated from the External Tank before it separated from the right hand Solid Rocket Booster.
