The Commission found that the cause of the
accident resulted from the failure of the
pressure seal in the aft field joint of the
right solid rocket booster.

The Cause of the Accident

The consensus of the Commission and participating investigative agencies is that the loss of the Space Shuttle Challenger was caused by a failure in the joint between the two lower segments of the right Solid Rocket Motor. The specific failure was the destruction of the seals that are intended to prevent hot gases from leaking through the joint during the propellant burn of the rocket motor. The evidence assembled by the Commission indicates that no other element of the Space Shuttle system contributed to this failure.

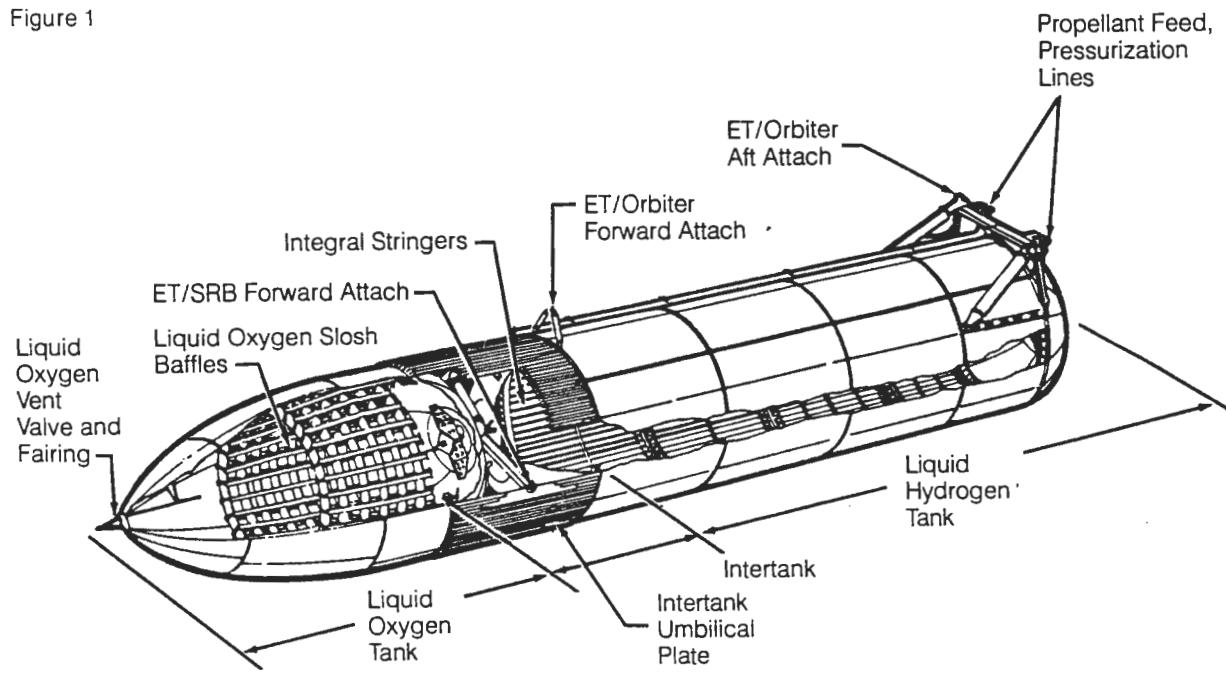
Figure 1

The possibility of an imperfection existing in either the pressurized or nonpressurized External Tank structural elements that could grow to a sufficient size to cause structural failure was examined in detail. All construction history, structural qualification test data, proof test inspection records and x-rays were reviewed. One previously

undetected imperfection that was discovered during a reexamination of the x-rays was found in recovered hardware with no propagation indicated.³ Other data from the pre-launch ice and frost team inspections, film and video coverage, pressurization records and flight data revealed no evidence of leakage. The Commission concluded that no structural imperfections existed that could have grown to a size to create a leak or cause catastrophic failure of the External Tank.

The recovered external foam insulation on the External Tank was scorched and discolored in various locations.⁸ Burn patterns across the pieces of insulation on the External Tank indicate that various areas were subjected to fire both before and after the External Tank broke up in flight.

The Commission reviewed the External Tank's construction records, acceptance testing, pre-launch and flight data, and recovered hardware and found nothing relating to the External Tank that caused or contributed to the cause of the accident.

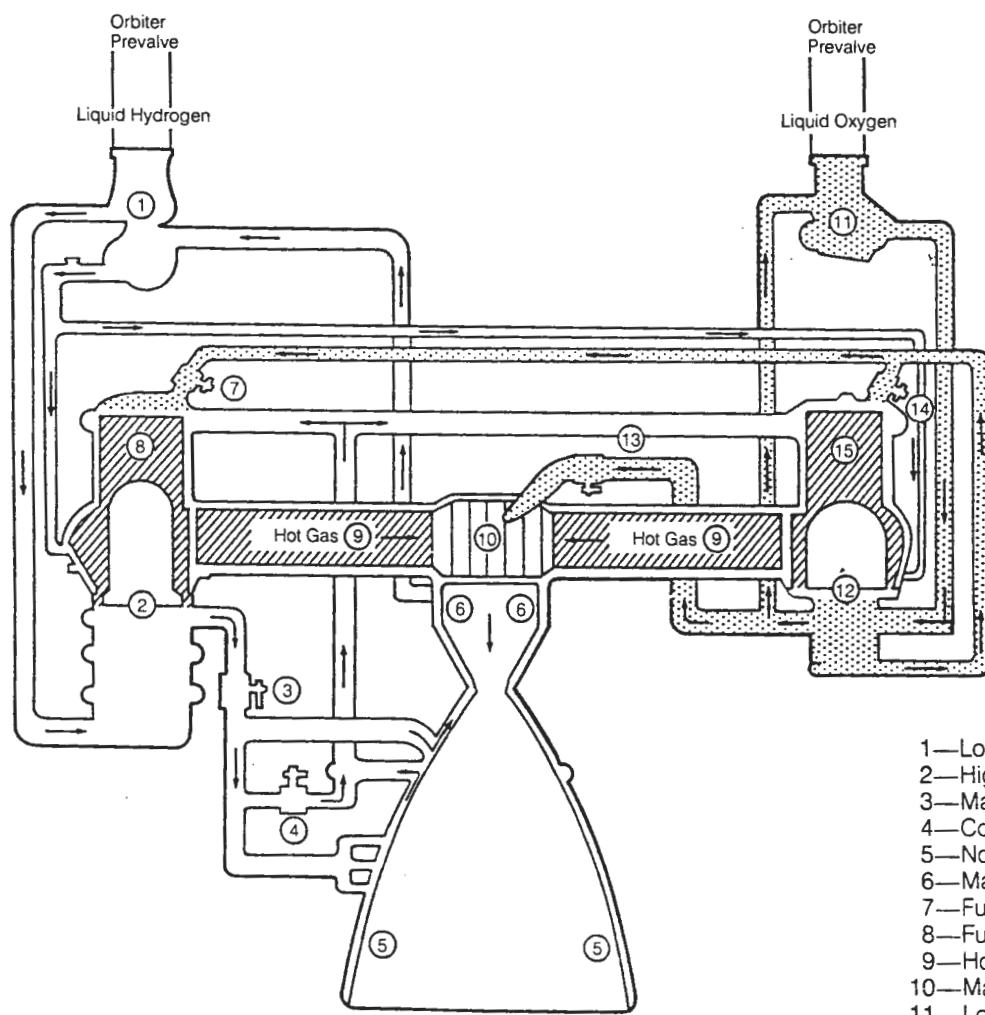
Figure 4

The first abnormal engine indication was a drop in engine fuel tank pressure at 72.564 seconds. As fuel pressure dropped, the control system automatically responded by opening the fuel flowrate valve. The turbine temperatures then increased because of the leaner fuel mixture.

The increased temperature caused an increase in pump speed. This could not, however, increase the fuel pressure because of a decrease in fuel tank top (ullage) pressure resulting from the burned through hydrogen tank leakage. When the fuel pump pressures dropped below 140 pounds per square inch, the programmed control system disqualified the measured data because it was past reasonable limits. This caused the fuel flowrate and high-pressure fuel pump discharge pressure to decrease, while the lack of load allowed the pump's speed to increase. The decreased fuel flow caused a drop in fuel preburner chamber pressure, though the fuel preburner oxygen valve was then advancing toward a more open position. The mixture ratio in the fuel preburner became leaner, which raised high-pressure fuel turbine discharge temperatures above the redline limits. This caused the engine control system to start automatic shutdown of the engine.

The analysis of flight data confirmed that the Space Shuttle Main Engines operated properly while reacting to changing external conditions. Previous engine tests suggest that the high-pressure pumps are the most likely components to fail, because of either bearing or turbine blade failure. There was no evidence of either in flight 51-L. Engine operation was normal until the fuel inlet pressure dropped. As the pressure decreased, the engine responded in a predictable manner. Automatic shutdown of engine 2023 was verified by telemetry data. Data recovered from the salvaged engine 2021 control computer verify that this engine also had begun shutdown. Salvaged control computer data from engine 2020 showed that this engine was within 20 milliseconds of shutdown when the computer stopped.¹⁸ Inspection of recovered engine hardware verified that all engines were shut down in a fuel-lean or oxygen-rich condition which resulted in burn through and erosion of the engine hot gas circuits.

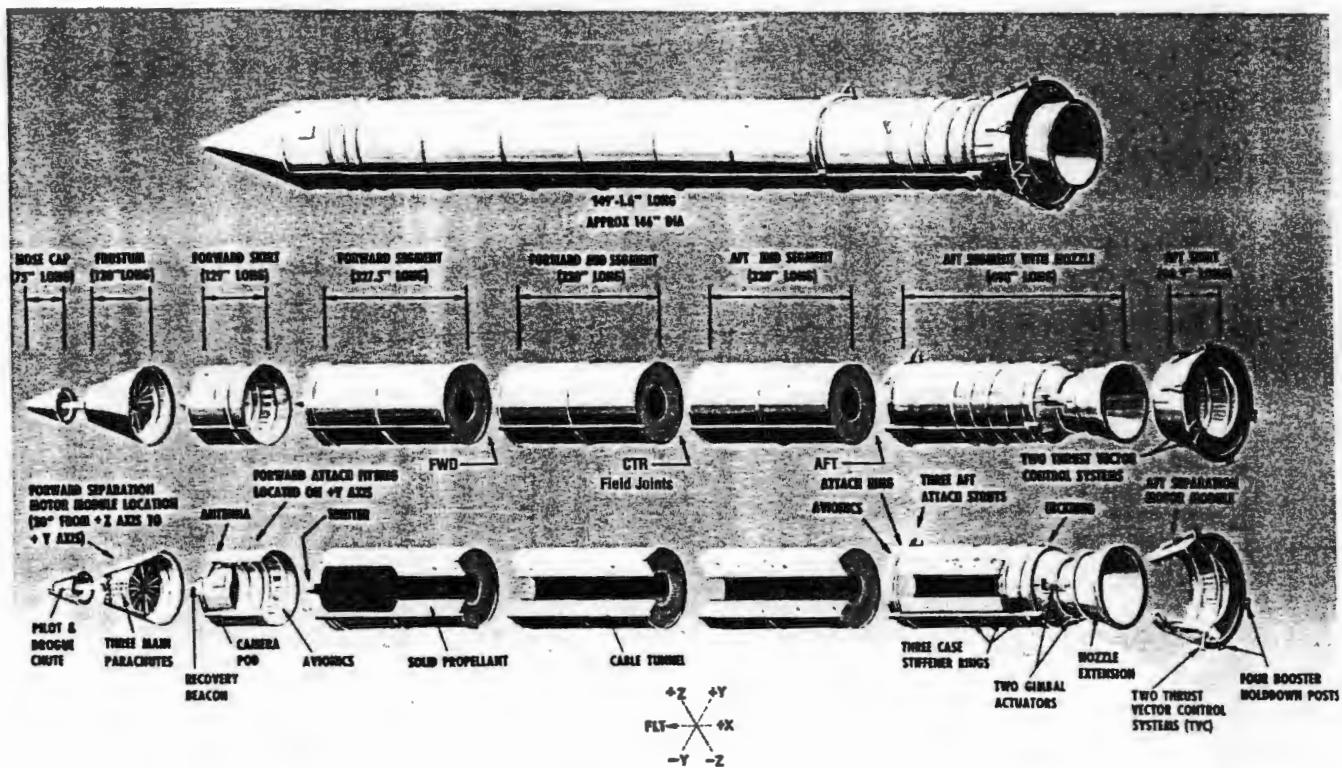
Reconstructed lift off and flight loads were compared with design loads to determine if a structural failure may have caused the accident. The STS 51-L loads were within the bounds of design and capability and were not a factor. Photographic and video imagery confirmed that both Solid Rocket Boosters remained structurally intact until the time of the explosion except for the leak observed on right Solid Rocket Motor.

Figure 8
Solid Rocket Booster drawing at top is exploded in lower drawings to show motor segments and other elements at forward and aft ends of booster.

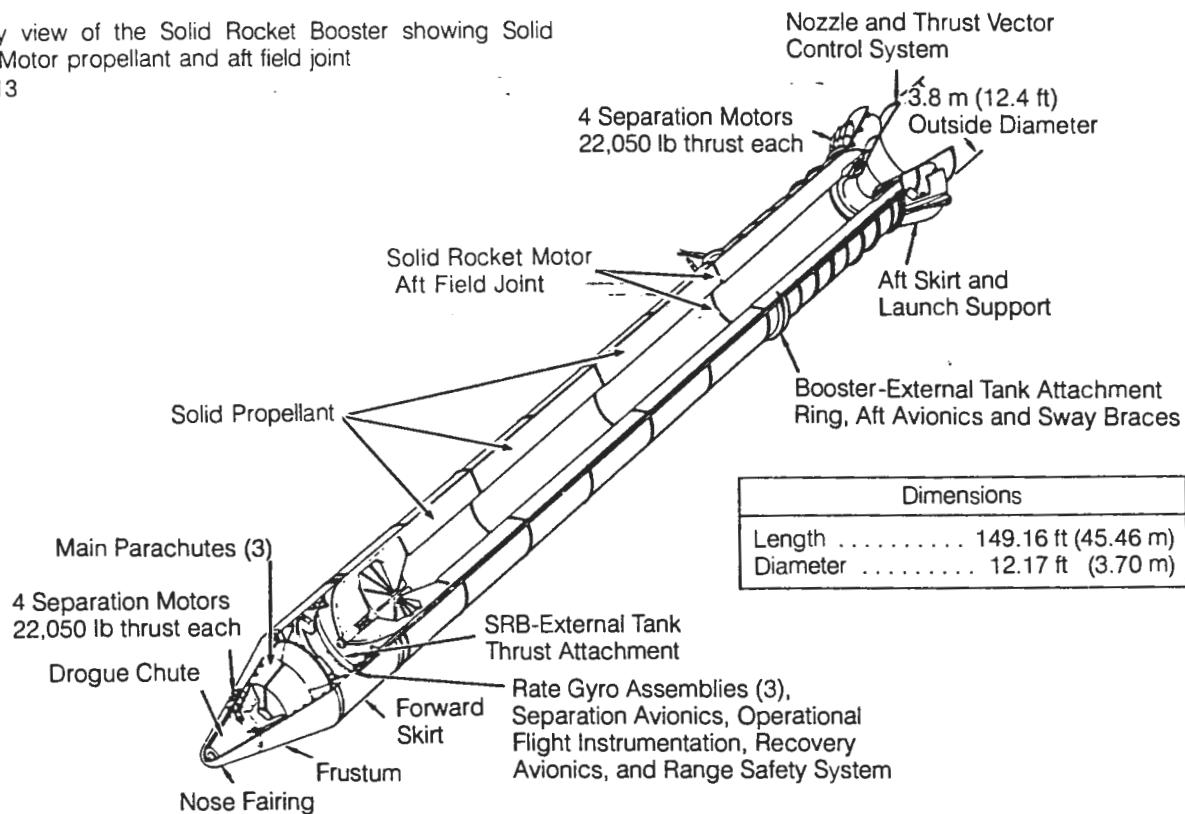
The hypothesis of a membrane failure requires that the initial smoke observed at 0.678 seconds was an independent occurrence. It is an unlikely hypothesis for initiation of the accident. Fracture mechanics analysis indicates that a hole in the

Cutaway view of the Solid Rocket Booster showing Solid Rocket Motor propellant and aft field joint
Figure 13

case larger than one inch would cause the entire case to rupture in a few milliseconds. This would give rise to the appearance of a large longitudinal flame, an event that is contrary to the flight films.

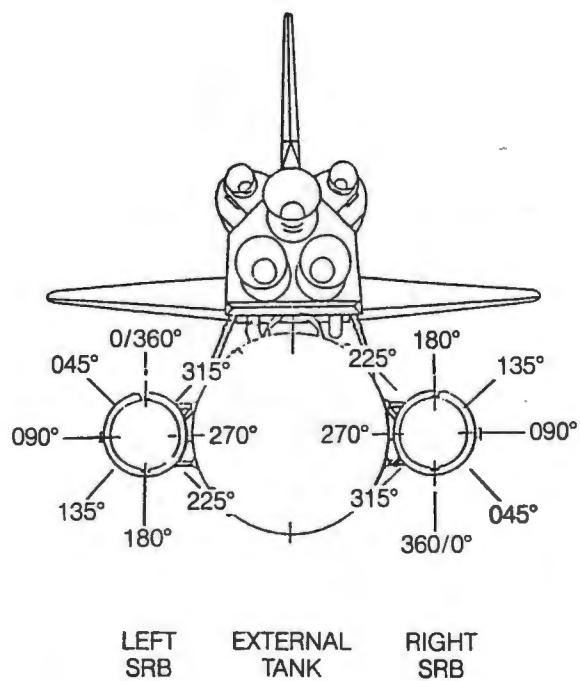
Angular Coordinate System
For Solid Rocket Boosters/Motors
Figure 26

parts 131, the upper segment tang region, and part 712; the lower clevis region of the joint. This burned area extends roughly from station 1476, in the upper section, to 1517 on the lower region. In a circumferential direction (see figure 26) the lower end of the eroded region extends from roughly 291 degrees to 320 degrees and the upper eroded section extends between 296 and 318 degrees. Note that the region at about 314 degrees includes the attachment region of the strut to the attachment ring on the right Solid Rocket Booster.

307-degree circumferential position. Although irregular, the hole is roughly rectangular in shape, extending approximately 27 inches circumferentially along the tang (296 to 318 degrees) with total burnout extension approximately 15 inches forward of the tang. At either side in the interior of the hole (photo K) the insulation and steel case material showed evidence of hot gas erosion that beveled these surfaces (indicative of combustion products flowing through the hole from the interior of the Solid Rocket Motor). The top surface of the hole was hardly beveled at all. The
